Hertford Theatre Weir  
East Herts District Council  
October 2014

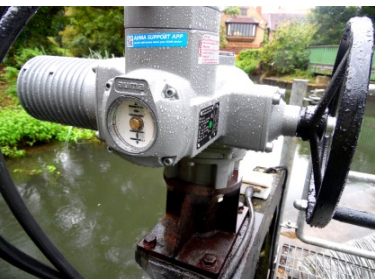
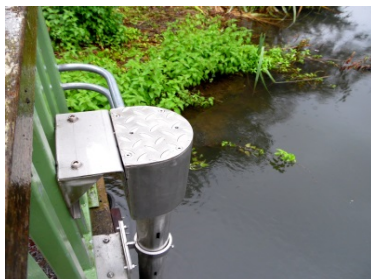
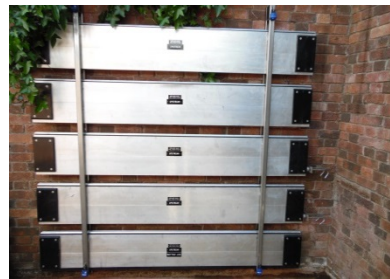
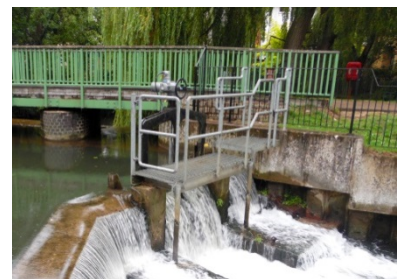
To allow us to complete the refurbishment work without involving the need for a major civil works programme, we constructed a 12 Metre Wide Temporary Dam across the river to allow us to inspect and repair the sluice gate mechanisms. These mechanisms had been permanently submerged in over two metres of water for many years and had received little or no regular maintenance. We also took this opportunity to install stop log guides on the upstream side of the sluice gates, thus avoiding the need for future dewatering of the complete river channel. This environmentally sensitive work phase also involved the need for us to implement a fish rescue and repatriation programme in accordance with Environment Agency Directives. We were also requested by the E.A. to investigate the possible integration of an eel passage within the existing structure in the event that, larger scale maintenance to the structure should be required in the future.

Over a period of time, PowerPoint repaired and refurbished the existing sluice gate mechanisms, fitted replacement electric actuators and supplied and installed aluminium stop log facilities to each sluice. Due to the age of the existing cast iron sluice gates, we were also called upon to design replacement parts needed for the sluice gates and arrange for these to be specially fabricated and machined to our specification.
